LANDSLIDE HAZARD AREA NOTICE	
Grantor:	<u>Terry Steeves + Ron Richards</u>
Grantee:	<u>The Public</u>
Tax Parcel #:	<u>2900 Account # 03073614290000</u>
Legal Description:	<u>N 1/2 of Section 43, T03N, R07E, W.M.</u>
NOTICE: This site lies within a landslide hazard area. Restrictions on use or alteration of the site may exist. For more information contact the City of Stevenson Planning Department.

**Subject: Geotechnical Investigation Report
Proposed Single Family Residence on Kanaka Creek Road
Tax Lot 2900 NE 1/4 of SE 1/4 Section 36, T3N, R7E, Willamette Meridian
Stevenson, Washington
EEI Report No. 13-079-1**

Proposed Richards-Steeves Residence
Tax Lot 2900 Kanaka Creek Road
Stevenson, Washington

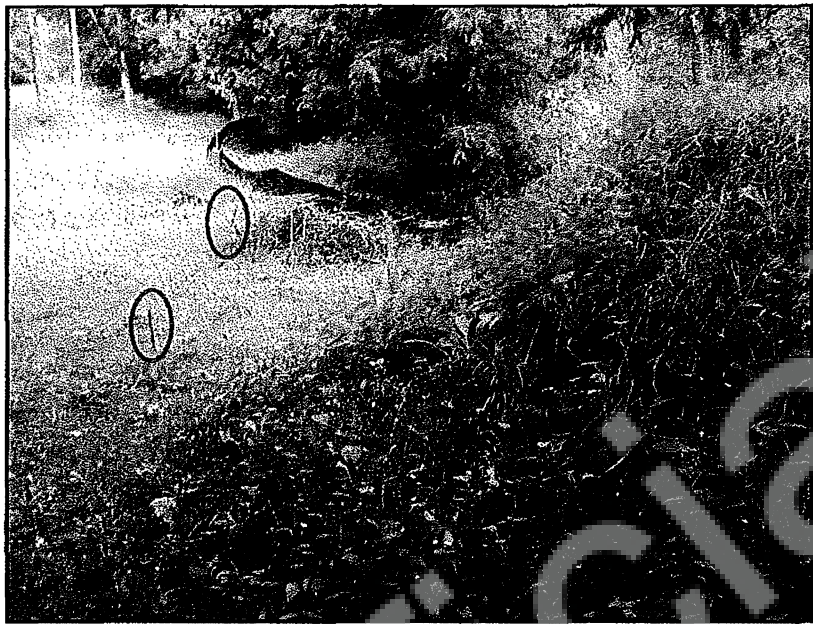
The fill near the southeast corner of the home site consists of a steep sided, grass covered mound of recently placed fill at the crest of the descending slope into the creek ravine. We understand that you or your excavation contractor directed placement of this mound of fill, intending to use it for backfill of footings and as a privacy screen. During our July 11, 2013 site meeting with you, EEI expressed concern for the weight of the fill at the crest of the ravine slope potentially initiating a slope failure. At that time we recommended removing the mound of the fill from the crest of the ravine slope.

Photo 1: View to north along approximate eastern footing line of proposed home. Mound of fill in the right foreground and brush covered fill near northeast corner are described in the report text above. Stakes circled in red represent the northeast and southeast corners of the proposed home.

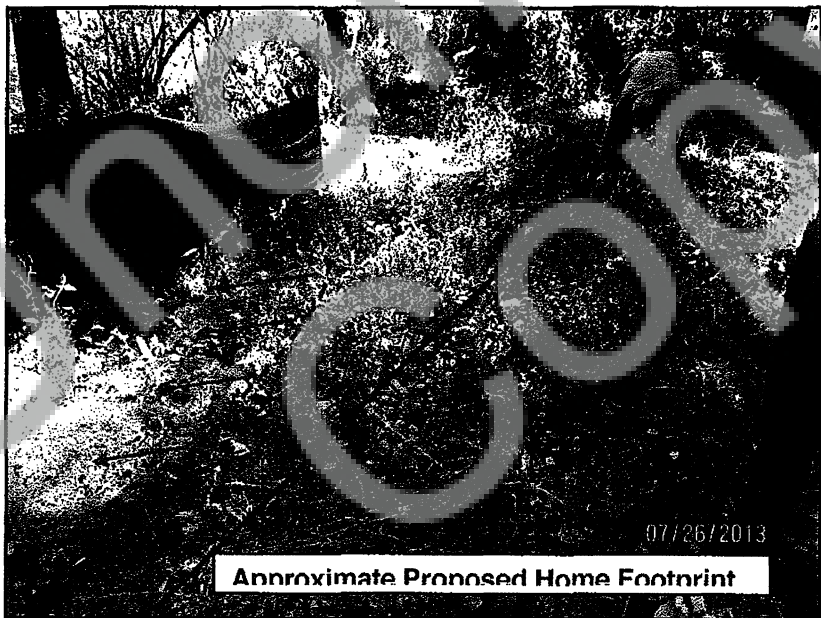
The manmade fill near the northeast building corner generally is present in what we interpret as the head of a lateral draw in the ravine slope or creek gulch. Silt fencing had been installed across the fill near the northeast building corner. Additionally, the fill appears to be creeping laterally down the slope as evidenced by several tension cracks that run parallel to the top of the slope, which have formed within the fill soils. During our July 11, 2013 site meeting with you, EEI recommended that because this fill appears to encroach into the northeast portion of the proposed building area, a subsurface exploration should be conducted in this area to characterize the fill and native soil. At that time we agreed that you would arrange to hire an excavator to remove the mound of fill from the ravine slope crest and we would coordinate a

Photo 2: Approximate northeast corner of proposed home as observed on July 26, 2013. The hashed red line indicates the fill mass that has slowly settled and crept laterally down the slope.

The organic fill, existing topsoil, and any other deleterious soils encountered during the excavation will need to be removed completely from proposed foundation areas. The depth of unsuitable fill in test pit TP-1 was approximately 4 to 4.5 feet below the excavated building pad elevation. It is possible that other unknown areas of fill may exist in structural areas. As stated above, once the fills and remnant organic soil has been removed, we recommend that the perimeter foundation subgrade on the eastern side of the proposed building be excavated a minimum of 2 feet into the native silty sand soils as measured on the eastern side of the excavation. EEI should be contacted at the time of site preparation and foundation excavation to document adequate removal of fill and embedment of foundation subgrade into firm soil below the original ground surface.

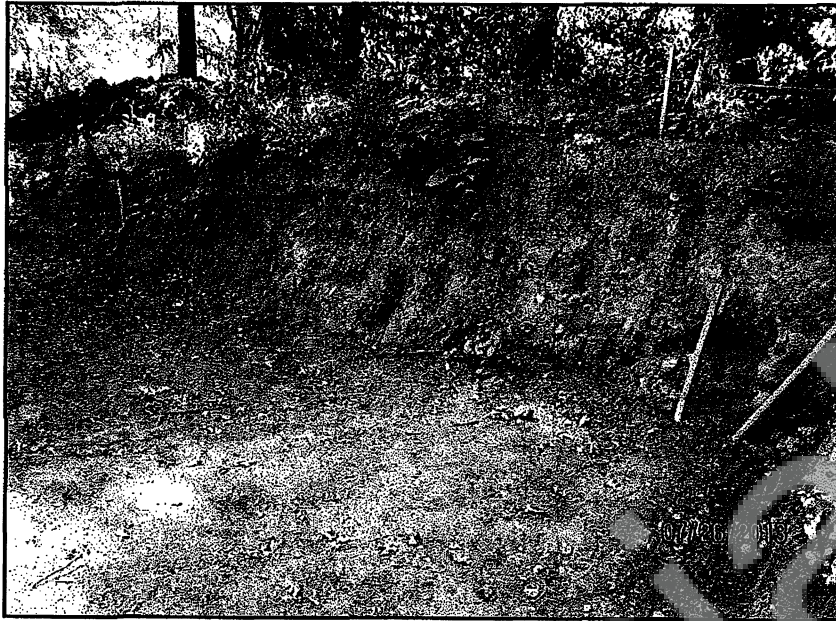
Photo 3: Western side of proposed home will have retaining/foundation wall; this is the existing 4 to 5 foot high cut slope of firm undisturbed native soil.

We understand that the west wall of the proposed home will be partially embedded below the height of an existing cut slope and will be designed as a retaining/foundation wall. In addition, it should be considered that the embedded stem wall of a deepened foundation on east side of the home may be required to serve as a retaining wall for soil under the home in the likelihood that the lateral exterior backfill and organic fill will continue to settle and creep down slope. Under these anticipated conditions we recommend that retaining wall foundations be designed in general accordance with the foundation recommendations of this report.

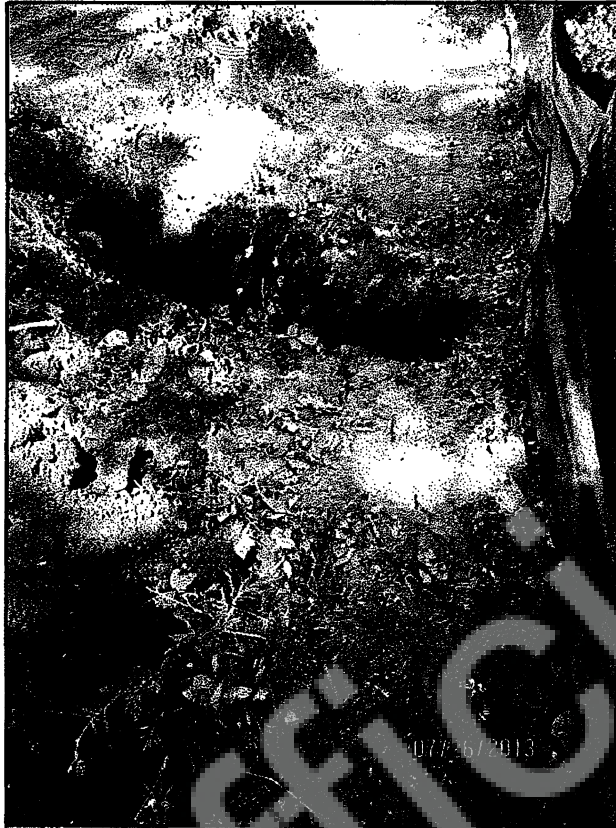
Photo 4: View to north of test pit TP-1 along eastern footing line. Note gray bucket in upper part of photograph is near proposed northeast building corner. Previous and current ground cracks (shown above) suggest that manmade fill is settling or sliding to east.
