LAND CORNER RECORD

T 6 N, R 5 E., W.M. SKAMANIA County
Corner Code No. A-13

Segregated Surveys:
Name: NW Section Corner--- Section 3 Corner No.:

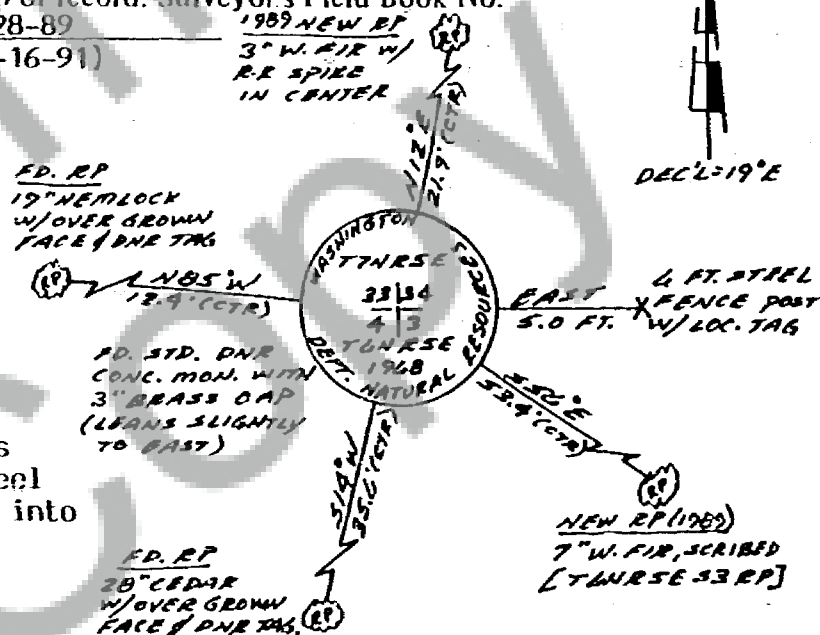
Found the DNR concrete mon. and 2 references, as shown in the diagram below.

-on a steep East slope, just above the
cut bank of old road grade, which
bears N10°W and S25°E.

-approx. 550 ft. South of "10 road",
at creek crossing; (fd. a 6"x6" DNR
post on South side of road with tag
which reads "South--554 S.D."

-near SW. corner of 2nd growth timber
and on edge of Old Growth timber.

Note: A Plum Creek location tag was added to each RP as well as the steel fence post. A R-R spike was driven into the side center of each RP.
