## LAND CORNER RECORD

T. 7 N.R. 5 E., W.M. SKAMANTA County  
 Segregated Surveys: Corner Code No. Z-13  
 Name: SW Section Corner--Section 34 Corner No.:  
 DLC, HES, Tract, Mining Claim, Indian Allotment, Federal Reserve, Townsite.

## 1. History of Corner Establishment and Subsequent Restoration:

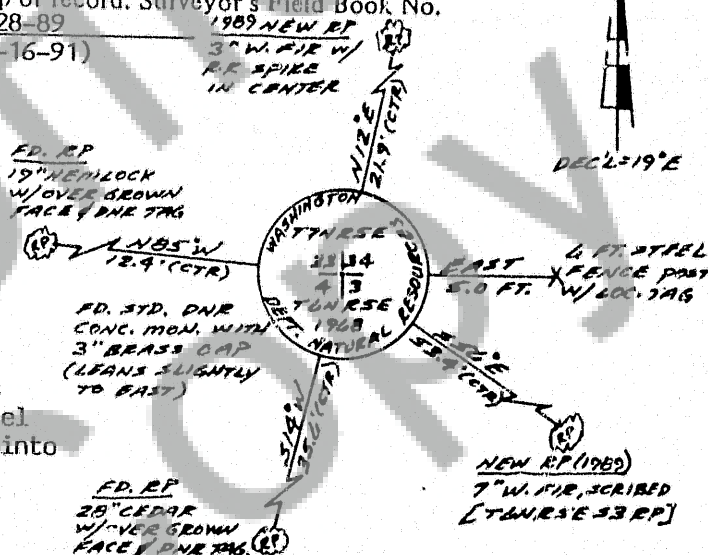
Found the DNR concrete mon. and 2 references, as shown in the diagram below.

-on a steep East slope, just above the cut bank of old road grade, which bears N10°W and S25°E.

-approx. 550 ft. South of "10 road", at creek crossing; (fd. a 6"x6" DNR post on South side of road with tag which reads "South--554 S.D.")

-near SW. corner of 2nd growth timber and on edge of Old Growth timber.

Note: A Plum Creek location tag was added to each RP as well as the steel fence post. A R-R spike was driven into the side center of each RP.
