February 20, 1997  
Revised August 17, 1998  
Revised August 31, 1998

Project No. EAAX-97-0158  
Report No. 09-027-2760

Re: Preliminary Site Stability Evaluation Report  
Meadow Short Plat, Baker Road, Stevenson, Washington

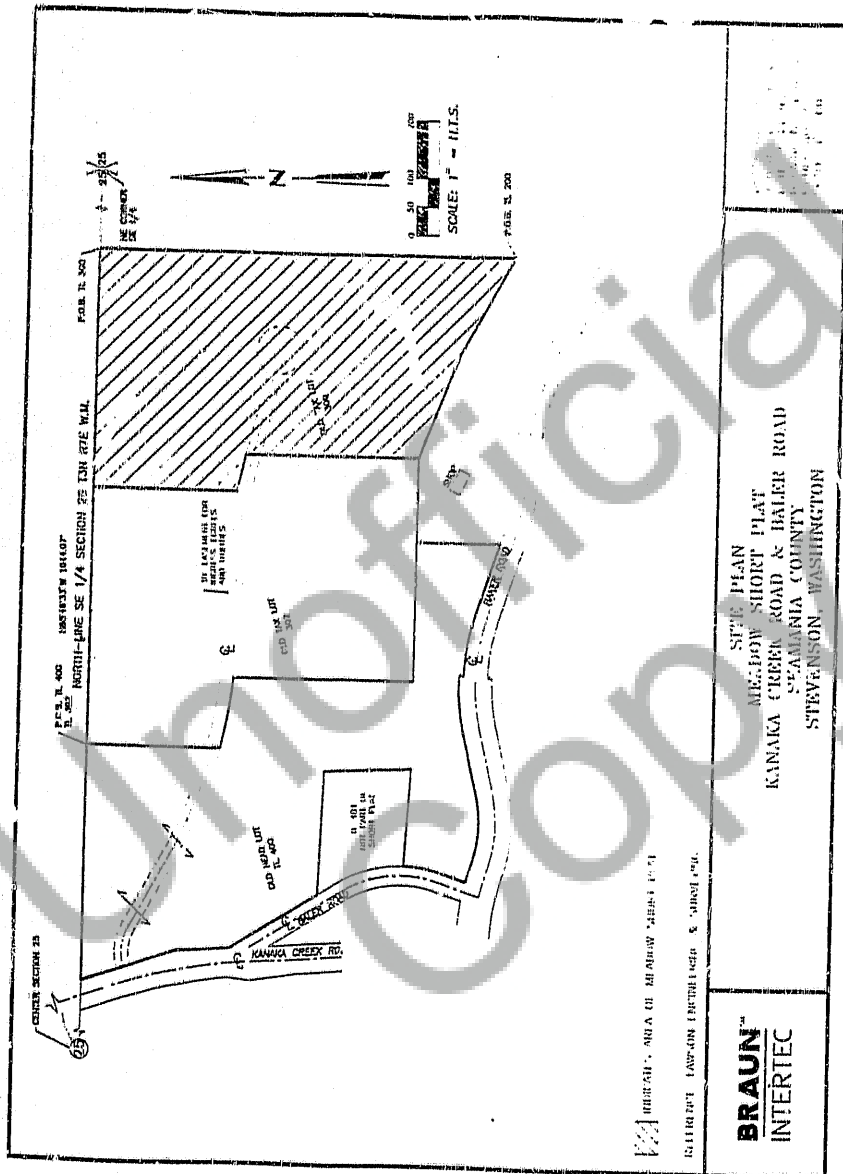
Attachments - Site Location Map, Figure 1  
 Lot Layout Plan - Figure 2

We understand that present plans are to develop the site into several individual lots as shown in an attached Lot-Layout Plan, Figure 2, prepared by Lawson Surveying and Engineering.
