February 20, 1997

Project No. EAAX-97-0158  
Report No. 09-027-2760

Re: Preliminary Site Stability Evaluation Report, 25-acre property, Baker Road, Stevenson,  
Washington

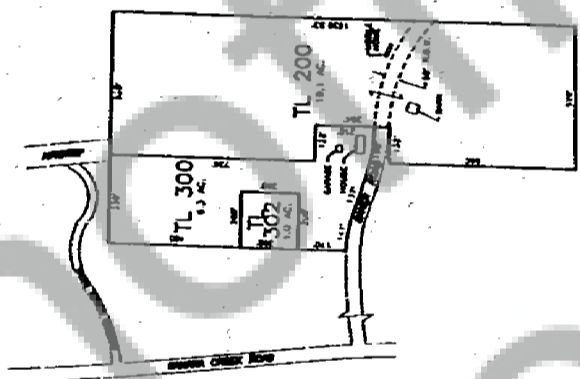
**Eagle's Nest Estates**  
Located in a portion of the SE 1/4  
of Section 26, T3N, R7E, Y.M.  
Stamand County, Va.

We understand that present plans are to develop the site into several individual lots and/or a subdivision as shown in an attached Schematic Site Plan, Figure 2, Sheets 1 through 5, prepared by Lawson Surveying and Engineering.
