LAND CORNER RECORD

T 7 N, R 5 E., W.M. SKAMANIA County
Segregated Surveys: Corner Code No. Z-13
Name: SW Section Corner---Section 34 Corner No.:
DLC, IIES, Tract, Mining Claim, Indian Allotment, Federal Reserve, Townsite.

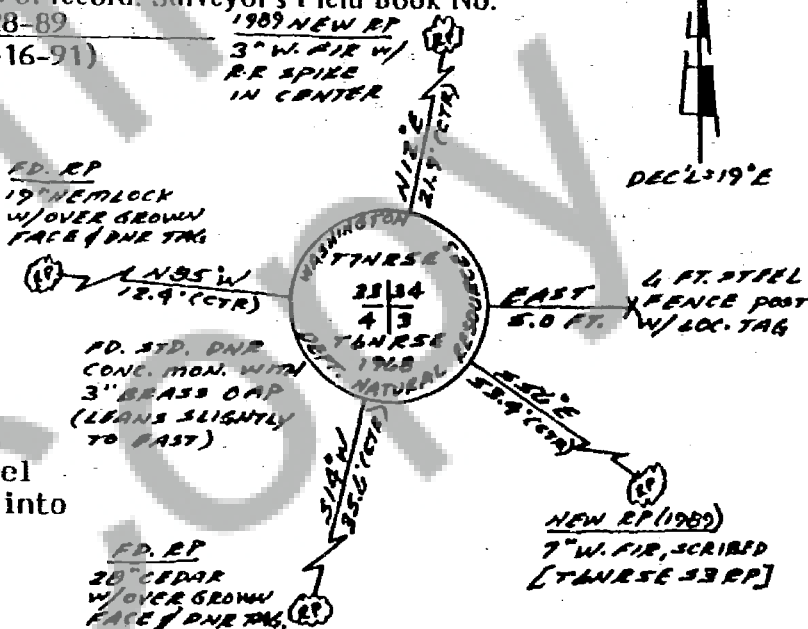
Found the DNR concrete mon. and 2 references, as shown in the diagram below.

- on a steep East slope, just above the cut bank of old road grade, which bears N10°W and S25°E.
- approx. 550 ft. South of "10 road", at creek crossing; (fd. a 6"x6" DNR post on South side of road with tag which reads "South--554 S.D.")
- near SW. corner of 2nd growth timber and on edge of Old Growth timber.

Note: A Plum Creek location tag was added to each RP, as well as the steel fence post. A R-R spike was driven into the side center of each RP.

- 10" Hemlock, N74°E--29 lks.; gone (falls in old road grade).
- 20" Hemlock, S28°E--48 lks.; fd. a 30" Hem. stump, 3 ft. high at rec. position.
- 20" Cedar, S08°W--54 lks.; gone (falls in old road grade).
- 20" Cedar, N55°W--26 lks.; fd. a 36" stump w/old axe work.
