# LAND CORNER RECORD

T 4 N, R 8 East, W.M. Skamania County  
 Segregated Surveys: Corner Code No. 2-5  
 Name: n/a Corner No.: n/a  
DLC, HES, Tract, Mining Claim, Indian Allotment, Federal Reserve, Townsite.

Shown on D.N.R. Final Map #462. See corner diagram on reverse side.

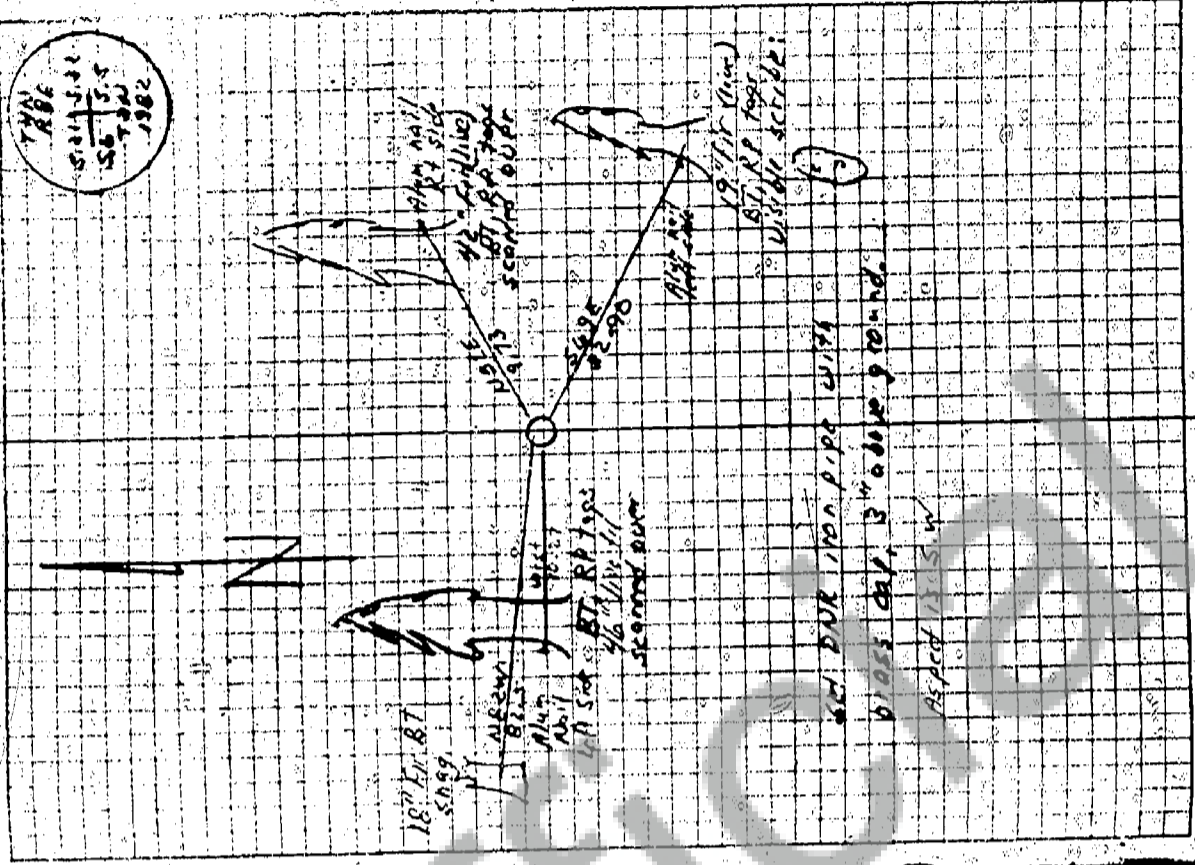
GLO Survey of 1896

East on N boundary Sec 6

78.88 Set post

24" Fir N48E 131.8 8.50'

14" Fir S72E 50L 33.00'

24" Fir West 151.1 9.90'

16" Fir N84W 125L 82.50

Section Corner 73E4N RDE

Found 3 like BT's & 1 rotted BT. S89.  
Opened up the SE BT and found remains  
of scribing on the badly burned face. Did  
not open the other BT's.

Set the pipe & cap by intersecting the  
distances from the BT's faces, allowing  
for growth on the 2 BT's not opened up.  
The pattern won't work by measuring from  
the centers of the BT's.
