State of Washington  
DEPARTMENT OF NATURAL RESOURCES  
**BUREAU OF SURVEYS AND MAPS**  
**LAND CORNER RECORD**

Skamania County

T 3 N, R 6 E, W.M.

Corner Code No. A-19

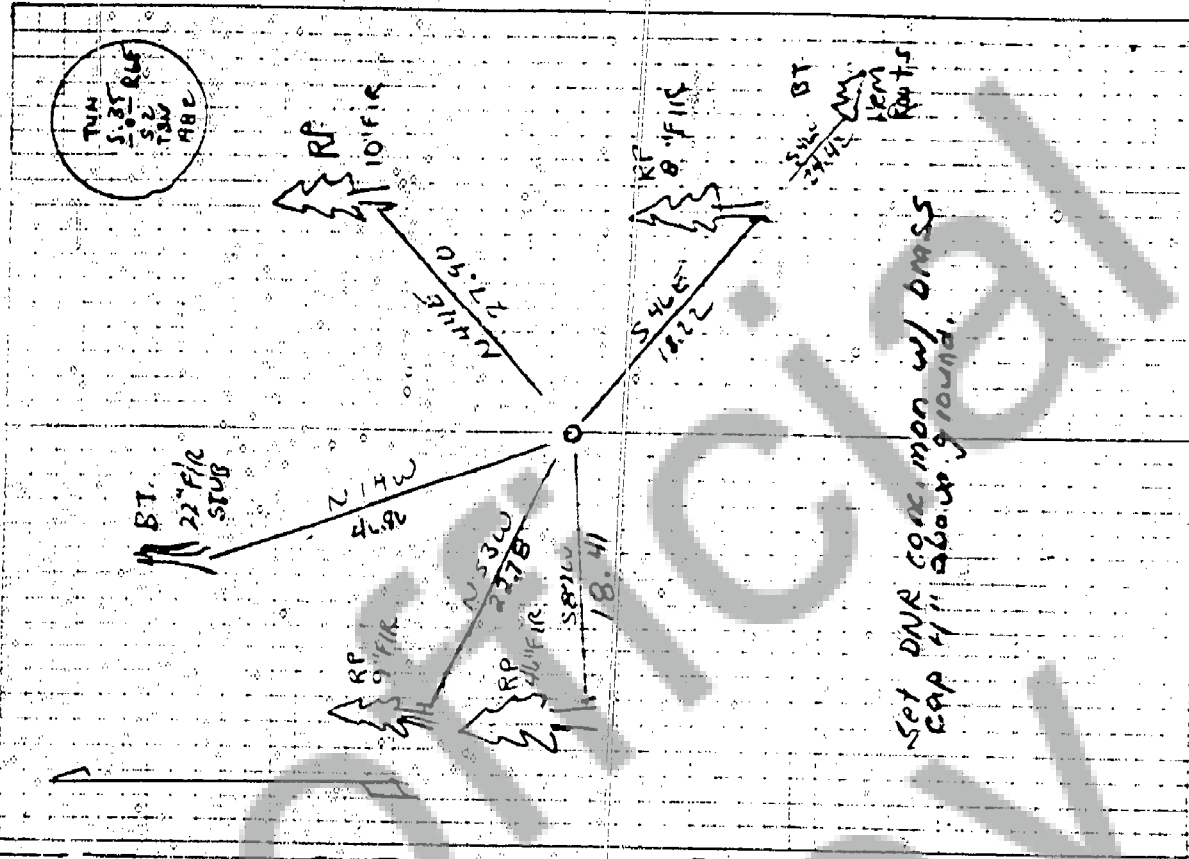
G40 of 1903  
 West between 2 & 35  
 38.00 brook 3 L. flows South  
 40.00 set post  
 dead 24" hemlock S 48° 30' E 37 L. <sup>24 42'</sup>  
 dead 24" Fir N 18 W 71 L 46.80'  
 42.00 creek 15 L. flows South

Found BT pattern as shown on sketch. Position fits creek calls to the east & west - see creek hrs on pages 21 & 22

Approx. 300' east of this position are 2 trees that had been blasted. Cutting out the blazes, it was determined by ring count that the blazes were made in the early 1950's.

Set DNR core, mon w/ brass cap 4" above ground.
