# LAND CORNER RECORD

SKAMANIA County

T 6 N, R 6 E, W.M.

Name: 1/4 corner between S.8/S.9

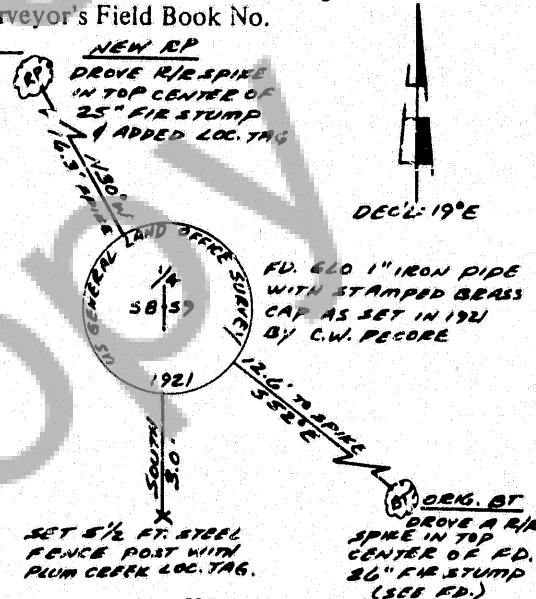
**ORIGINAL GLO CORNER:** (1"x36" iron pipe with brass cap, 28" in ground); fd. corner as described in good condition.

- (16" Fir, S52°E--18 lks.); fd. a 26" stump, 4 ft. high, with heal-over and vis. scribe [BT] at record location--added a R/R spike to the top center and reference tags.
- (10" Fir, S30°W--11 lks.); fd. only a stub rotted-off at the ground at record location.

- on a 75% North slope.
- approx. 150 ft. South of a creek, which runs W-NW.
- S55°E--approx. 200 ft. from same creek where it passes under road in culvert.
- South--approx. 250 ft. from a landing on a spur road.
- in area of recent clear-cut.

Note: Blue paint and PLUM CREEK location tags were added to all references during this time.
