LAND CORNER RECORD

T 7 N, R 6 E, W.M.

Corner Code No. Z-5

Name: SW corner of Section 32

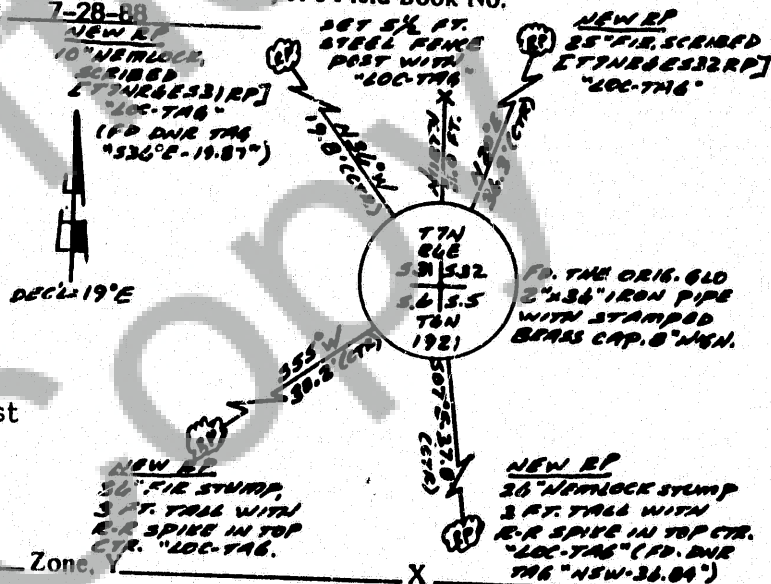
1921 ORIGINAL GLO MONUMENT: fd. the 2"x36" iron pipe with brass cap, set by Pecore in 1921 as mentioned above and shown in the diagram below.

- 10" Fir, N21 $\frac{1}{2}$ °E--25 lks.; fd. an uprooted, decayed 20 ft. stub, lying Northeasterly.
- 16" Fir, S48 $\frac{1}{2}$ °E--22 lks.; fd. 30" tree, uprooted and lying to the Northeast
- 8" Fir, S56°W--30 lks.; gone--position falls in old fire trail.
- 8" Fir, N17°W--32 lks.; gone--found scattered remains of decayed wood at record loc.

Found 4 RP's being DNR tags on small trees.

- on a NE. slope, approx. 75 ft. South of abrupt descent.
- on an existing E-W cutting line, with mature timber to the North and clearcut to the South.
- approx. 100 ft. North of an E-W spur ridge.
- approx. 100 ft. West of an abrupt descent.
- 5 ft. North of an E-W fire trail.
- approx. 150 ft. North and 350 ft. East from the end of road #1062.
