## LAND CORNER RECORD

**GRANTEE:** PUBLIC **SEAL/SIGNATURE/DATE**  
**LEGAL:** SECTION CORNER 23,24,25,26 TWP: 4 NORTH RGE: 7 EAST CORNER CODE: R21

**COUNTY:** SKAMANIA

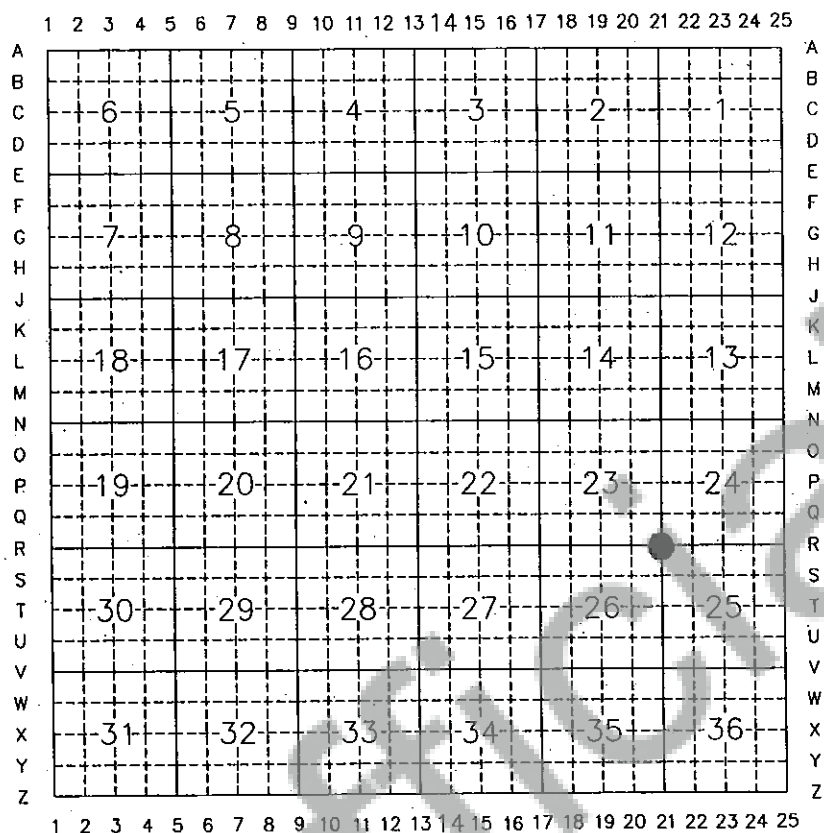
MARK THE CORNER LOCATION BELOW AND FILL IN THE CORNER CODE BLANK ON THE OTHER SIDE:  
For corners at the intersection of two lines, the corner code is the alphanumeric coordinate that corresponds to the appropriate intersection of lines.

For corners that are only on one line, the corner code is the line designation and the related line segment; i.e., a corner on line 5 between 'B' and 'C' is designated BC-5.

For corners that are between lines, the corner code is both line segments; i.e., a corner in the SE1/4 of the SE1/4 of section 18 is designated MN 4-5.

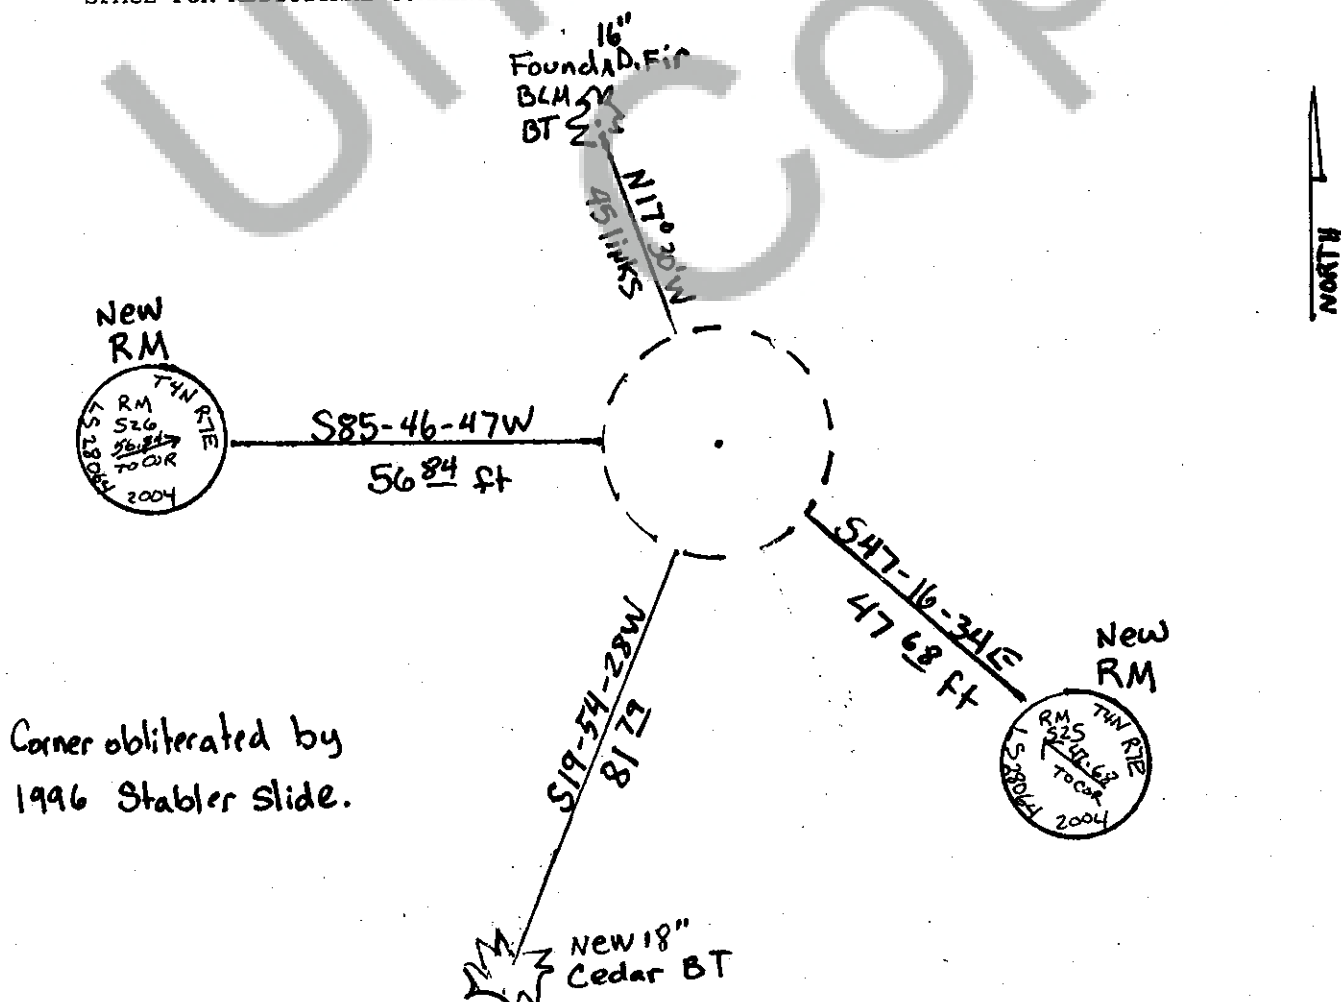
SPACE FOR ADDITIONAL COMMENT:

On Sept 8, 2004 I searched for the corner, and found that it has been obliterated by the 1996 Stabler Slide. Corner sits in the finger of slide and is not suitable for remonumentation.

12" now 16" Douglas fir live with overgrown face blaze. Attention sign and BT tags are visible. Painted red 6" band and face of BT.

Set a 5/8"X 30" iron rebar with a 2" aluminum cap, flush with ground, S85°46'47"W, 56.84 ft. from the section corner position as determined by record call from found NW BT. Placed carsonite guard post, marked Land Survey Monument, behind the RM facing the section corner.

Set a 5/8"X 30" iron rebar with a 2" aluminum cap, flush with ground, S47°16'34"E, 47.68 ft. from the section corner position as determined by record call from found NW BT. Placed carsonite guard post, marked Land Survey Monument, behind the RM facing the section corner.

An 18" Cedar bearing S19°54'28"W, 81.79 ft. scribed "T4N R7E S26 BT."  
Placed "BT" tag and "Land Survey Monument" signs on BT. Placed washer in tree face, and nail at side center. Painted red 6" band and face of BT.
