Record of Survey of portions of the Southwest Quarter of Section 23, the East Half of Section 24, the Northwest, Southwest and Southeast Quarters of Section 26, the Southwest Quarter of Section 27, the Southeast Quarter of Section 28 and the Northeast Quarter of Section 34, all in Township 3 North, Range 5 East, W.M. in Skamania County, Washington.

(Page 2 of 6 Pages)

Record of Survey of portions of the Southwest Quarter of Section 23, the East Half of Section 24, the Northwest, Southwest and Southeast Quarters of Section 26, the Southwest Quarter of Section 27, the Southeast Quarter of Section 28 and the Northeast Quarter of Section 34, all in Township 3 North, Range 5 East, W.M. in Skamania County, Washington.
(Page 3 of 6 Pages)

Record of Survey of portions of the Southwest Quarter of Section 23, the East Half of Section 24, the Northwest, Southwest and Southeast Quarters of Section 26, the Southwest Quarter of Section 27, the Southeast Quarter of Section 28 and the Northeast Quarter of Section 34, all in Township 3 North, Range 5 East, W.M. in Skamania County, Washington.
(Page 4 of 6 Pages)

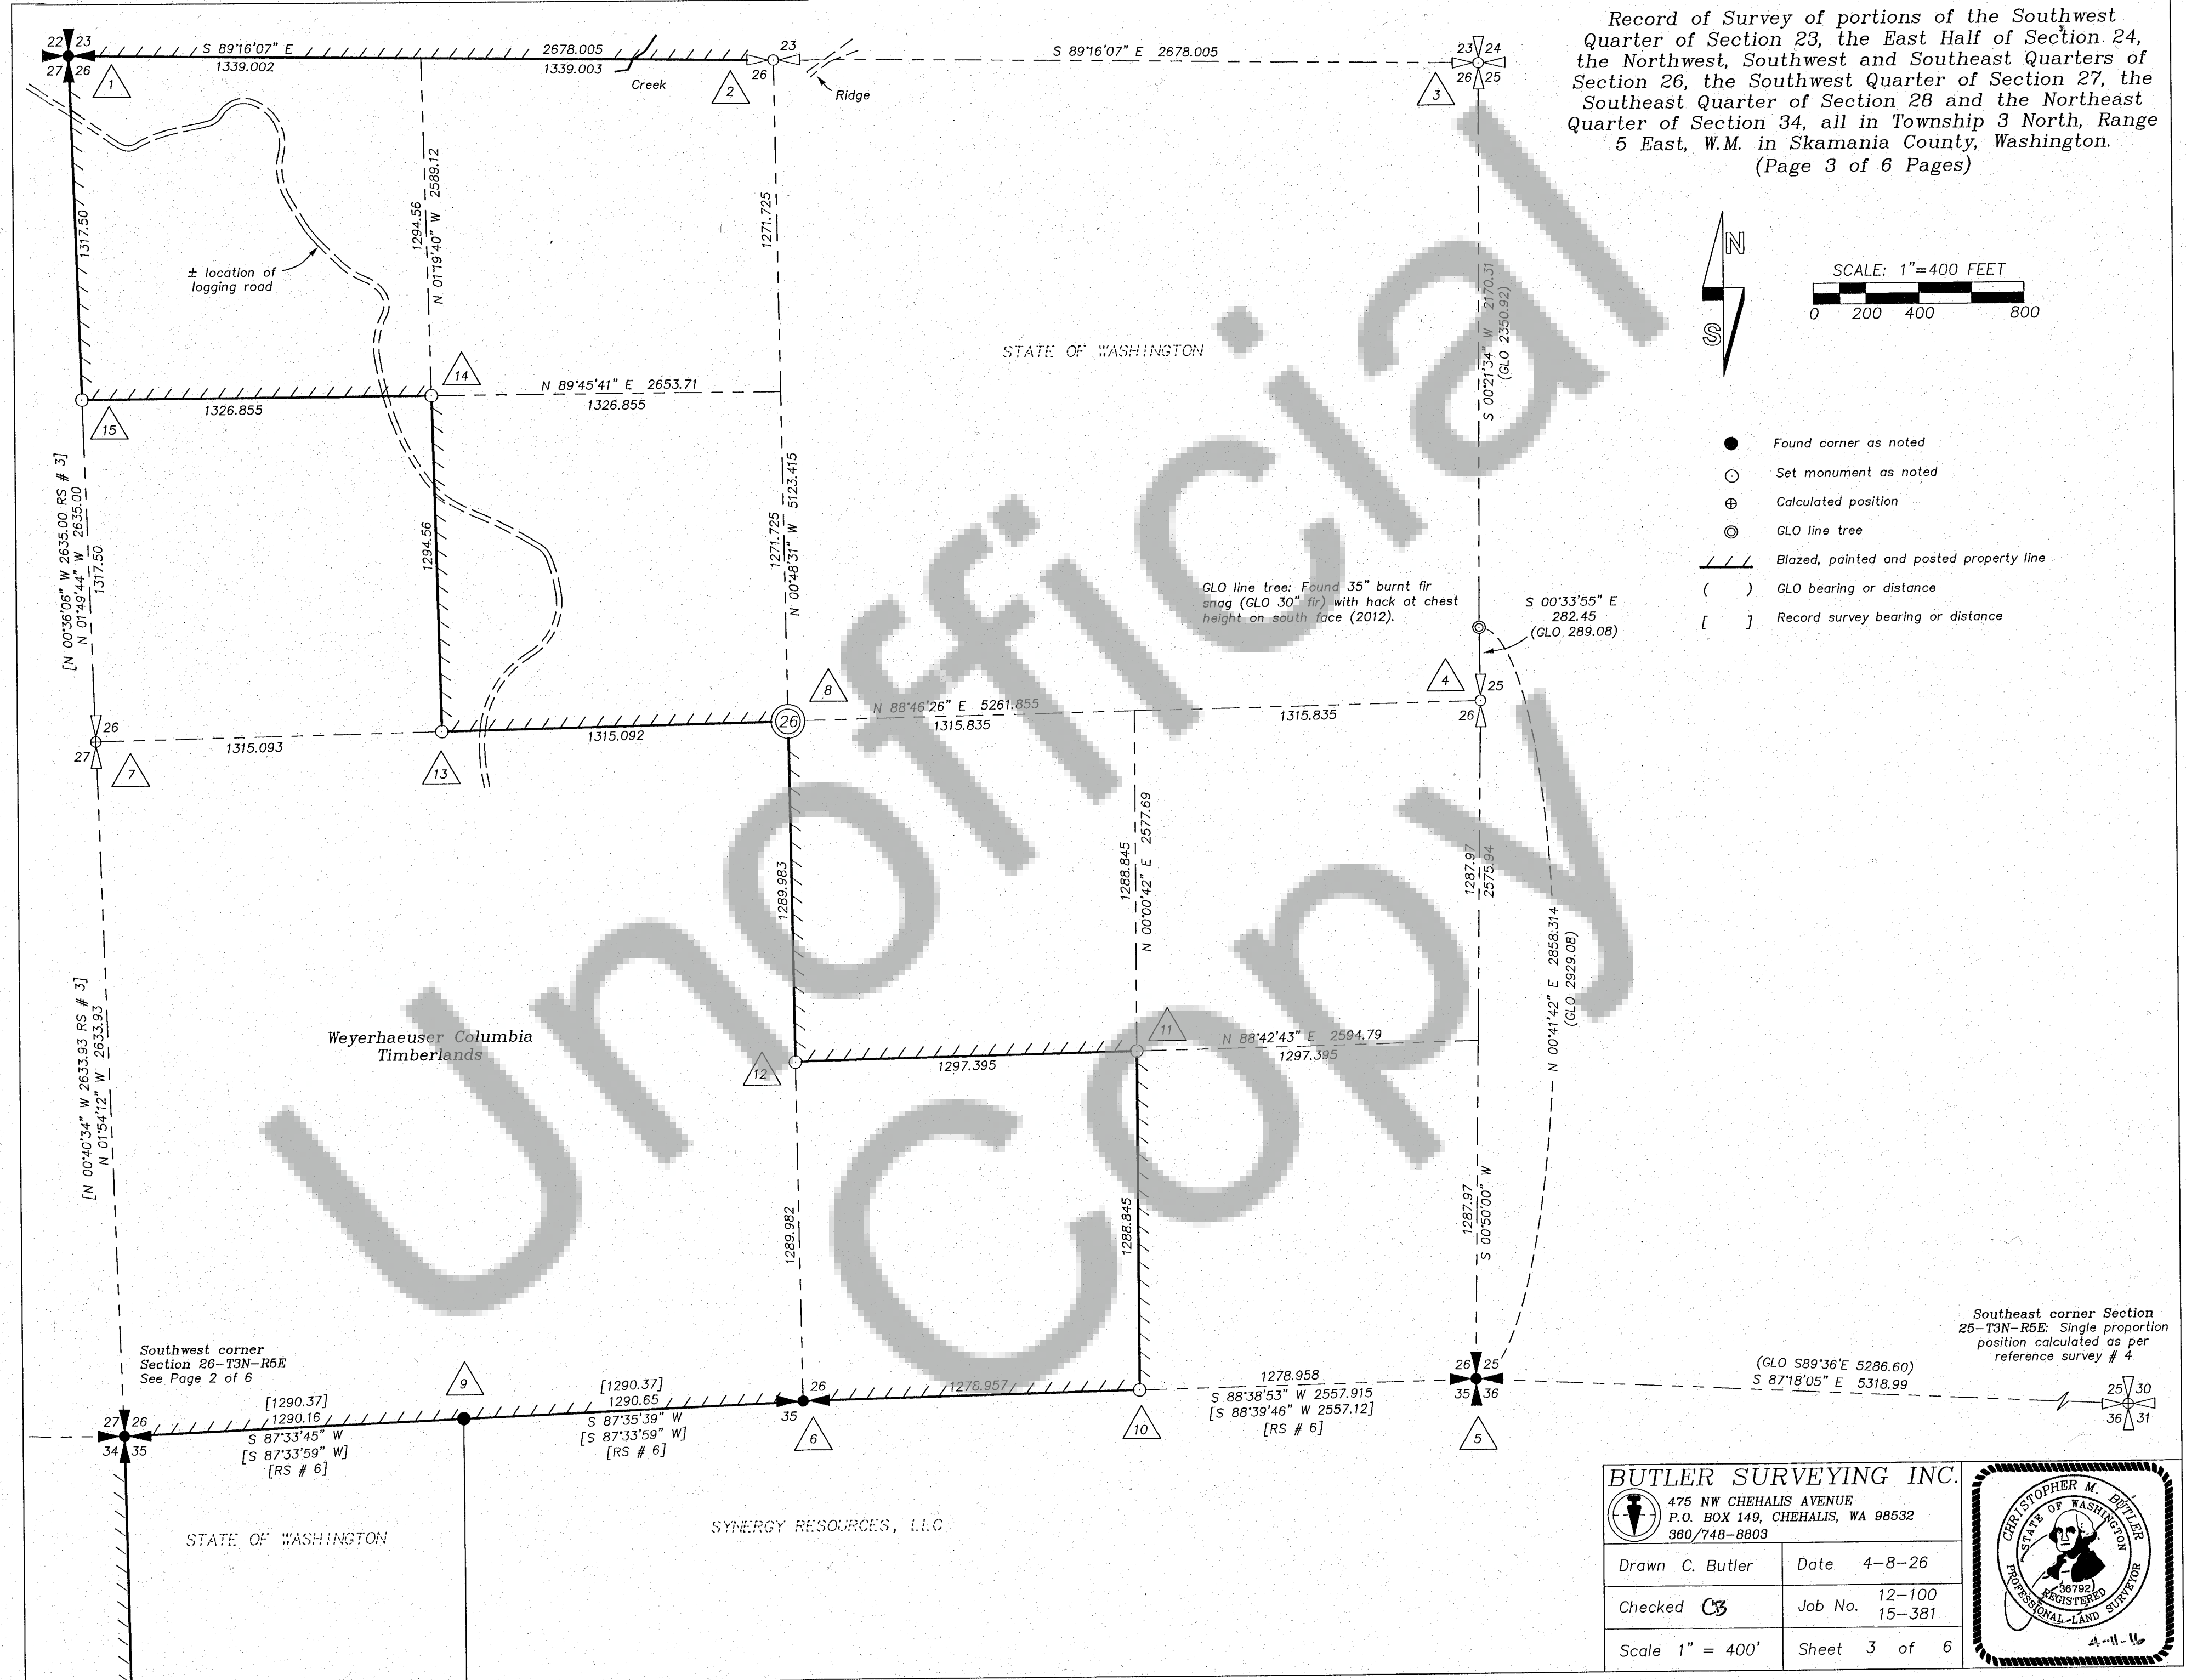
1 Northwest corner Section 26-T3N-R5E: Found and accepted the concrete monument with DNR brass cap as noted on reference survey # 3 (2012).

2 North 1/4 corner Section 26-T3N-R5E: No original GLO evidence of this corner was recovered by this survey. At the single proportion position depicted hereon this survey set a Berntsen G3250 (1"x30") drive rod with 3" aluminum cap stamped as per BLM Manual and established the following accessories:

GLO ground calls: This survey located a 4' wide stream flowing N42°E at a point 530' West of the set corner (GLO "1 lk creek runs North" West 590.7'). This survey also located an unmistakable ridge running N57°E at a point 215' East of set corner (GLO "top of ridge NW x SE" East 650.1'). This supports the theory promoted on reference survey # 3 that is explained in the narrative on Page 2 and depicted on Page 3 that GLO surveyor Webster likely did not close all of his traverses and many of the quarter corners in the township were set at the ends of stub traverses.

3 Northeast corner Section 26-T3N-R5E: This survey set a Berntsen G3250 (1"x30") drive rod with 3" aluminum cap stamped as per BLM Manual from the following recovered original evidence:

4 East 1/4 corner Section 26-T3N-R5E: This survey set a Berntsen G3250 (1"x30") drive rod with 3" aluminum cap stamped as per BLM Manual from the following recovered original evidence:

** As noted, this survey holds that the GLO bearing tree measurements were correct, but that the tree size and species were reversed in the original notes.

5 Southeast corner Section 26-T3N-R5E: Found and accepted the 5/8" rebar with aluminum cap LS 22330 as established from a GLO stump pattern and ground calls on reference survey # 5 and as noted on reference survey # 6 (2012).

6 South 1/4 corner Section 26-T3N-R5E: Found and accepted the concrete monument with DNR brass cap established from original evidence and noted on reference surveys # 3 and 6 (2012).

8 Center 1/4 corner Section 26-T3N-R5E: At the position depicted on Page 3 this survey, set a Berntsen G3250 (1"x30") drive rod with 3" aluminum cap stamped as per BLM Manual and established the following accessories (2013):

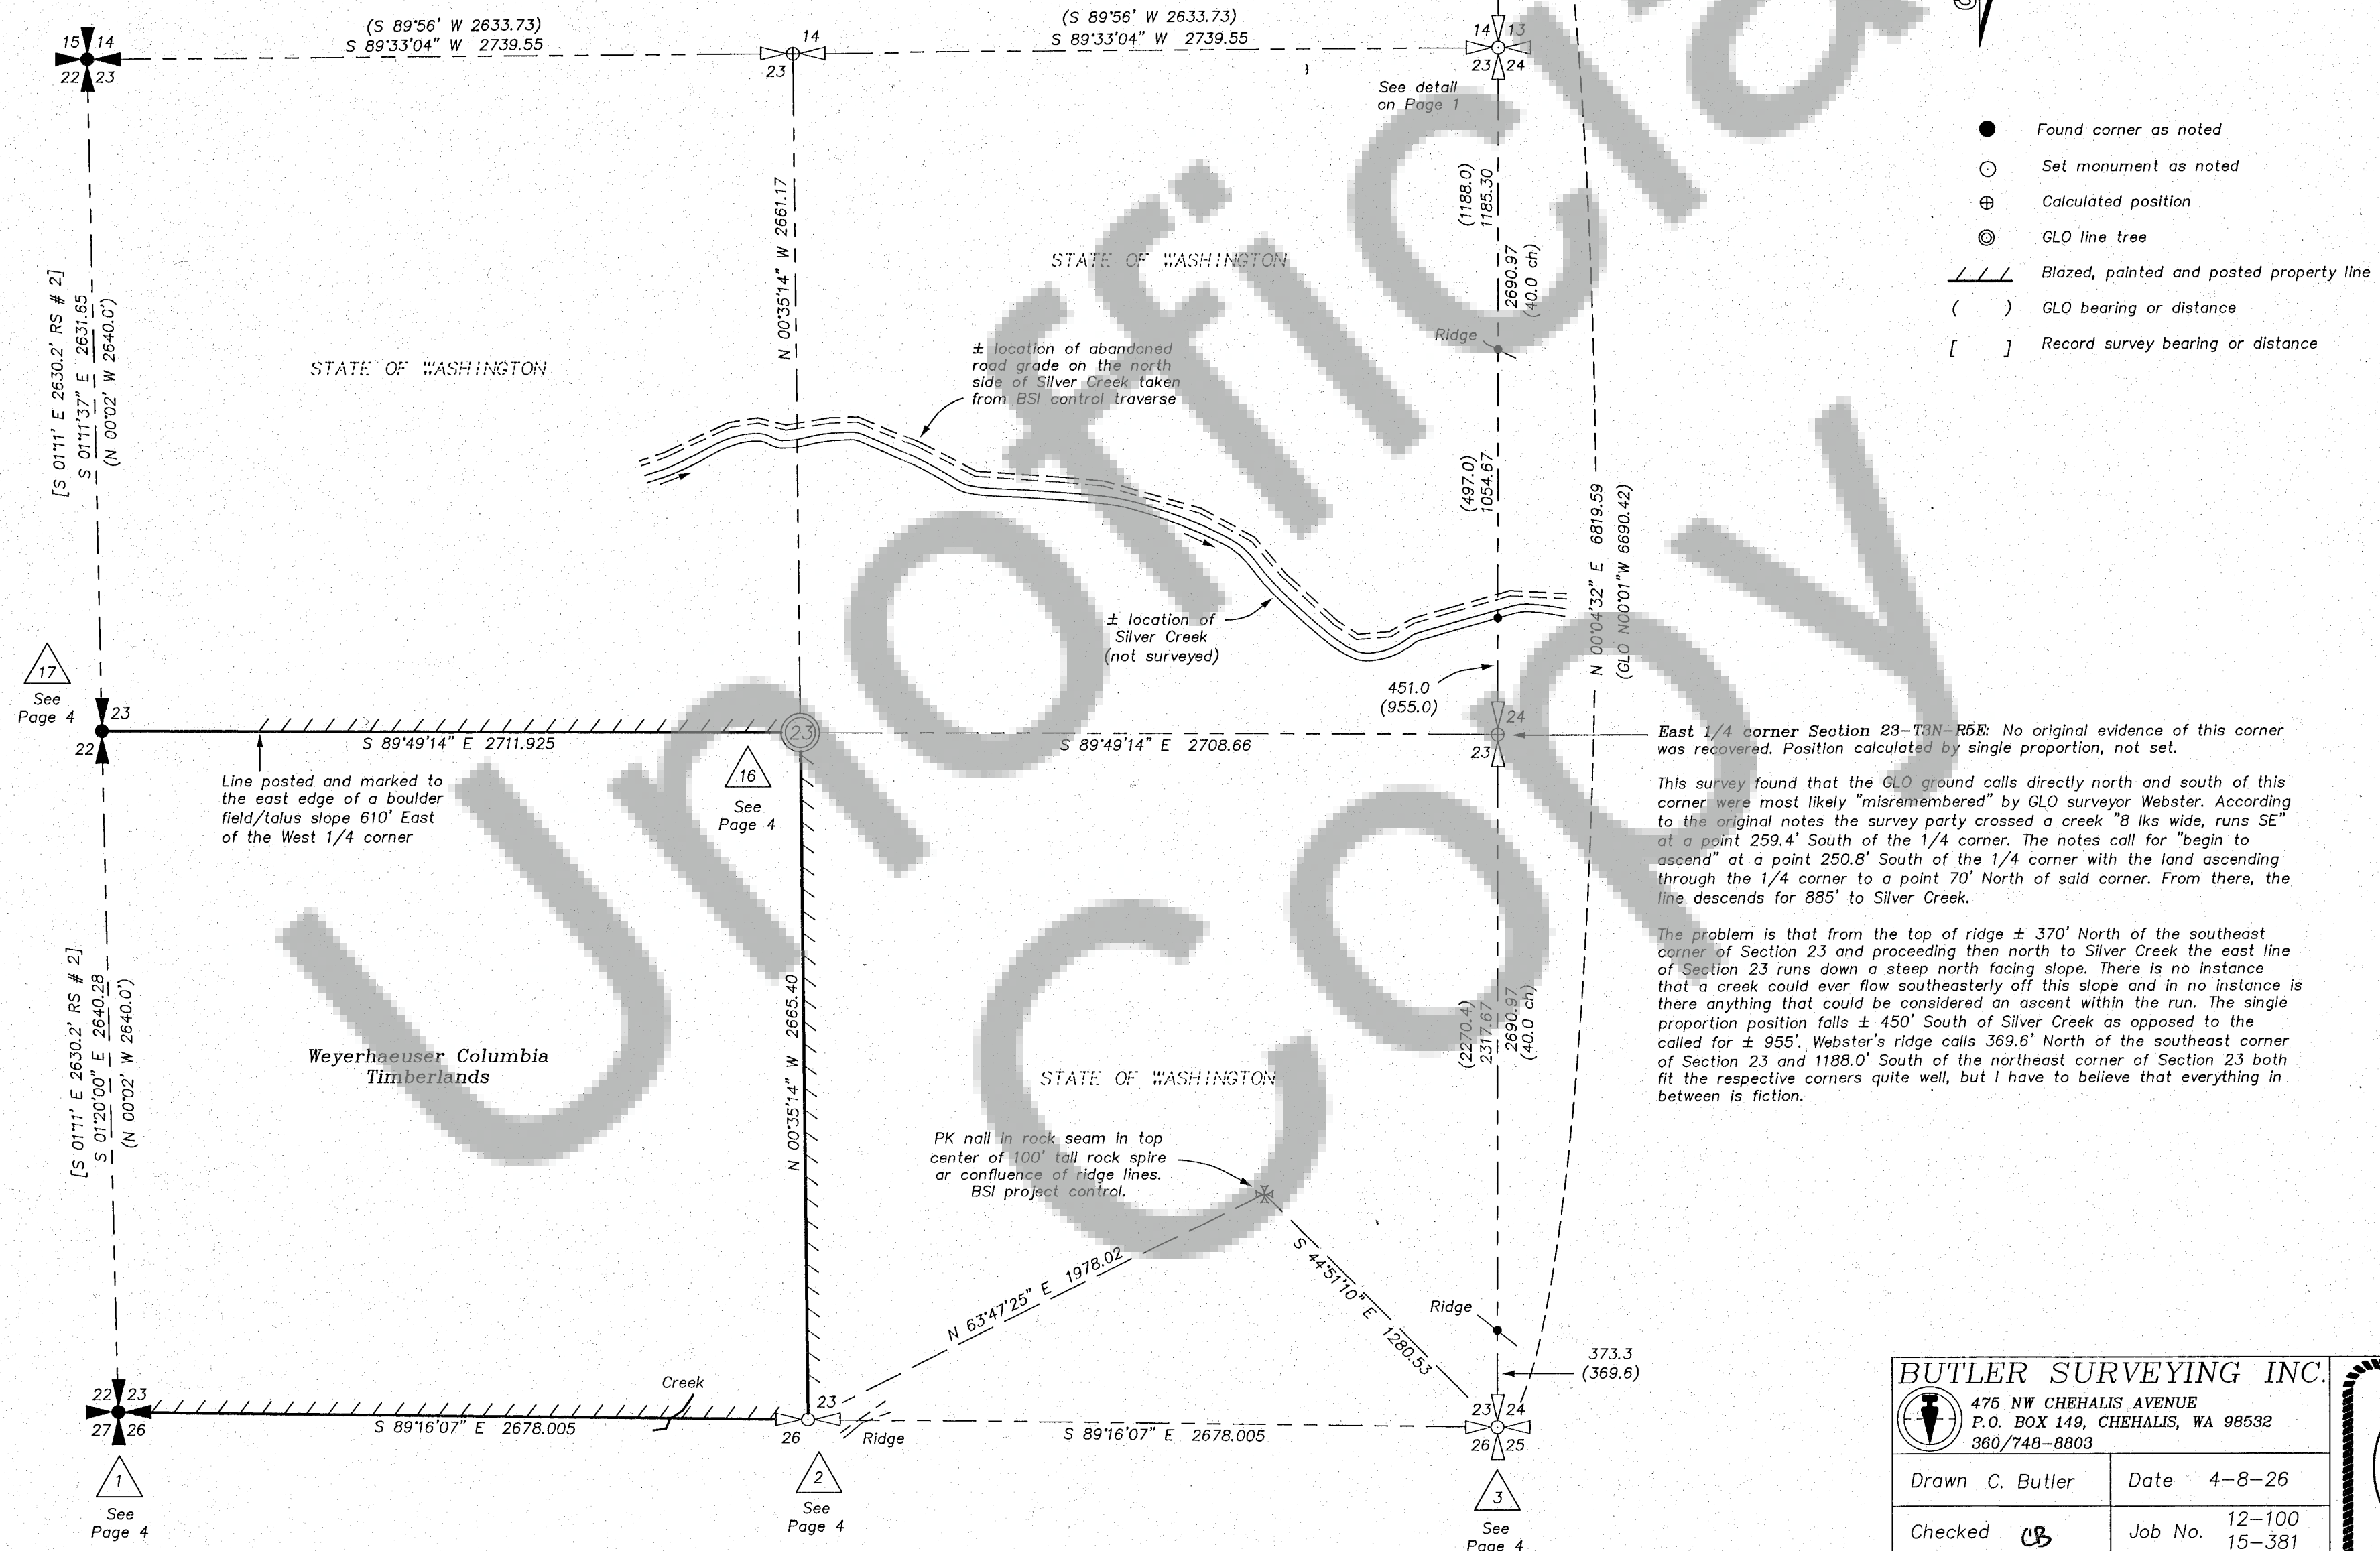
17 Center 1/4 corner Section 23-T3N-R5E: Set a Berntsen G3250 (1"x30") drive rod with 3" aluminum cap stamped as per BLM Manual at the position depicted on Page 5 of this survey and established the following accessories:
